June 28, 2019
File No. 262018.063

Subject: Department of Natural Resources Washington Geological Survey,
School Seismic Safety Assessment Project, Contract No. AE 410 -
Seismic Evaluation for **Dayton School District**

School Buildings Evaluated in the Dayton School District

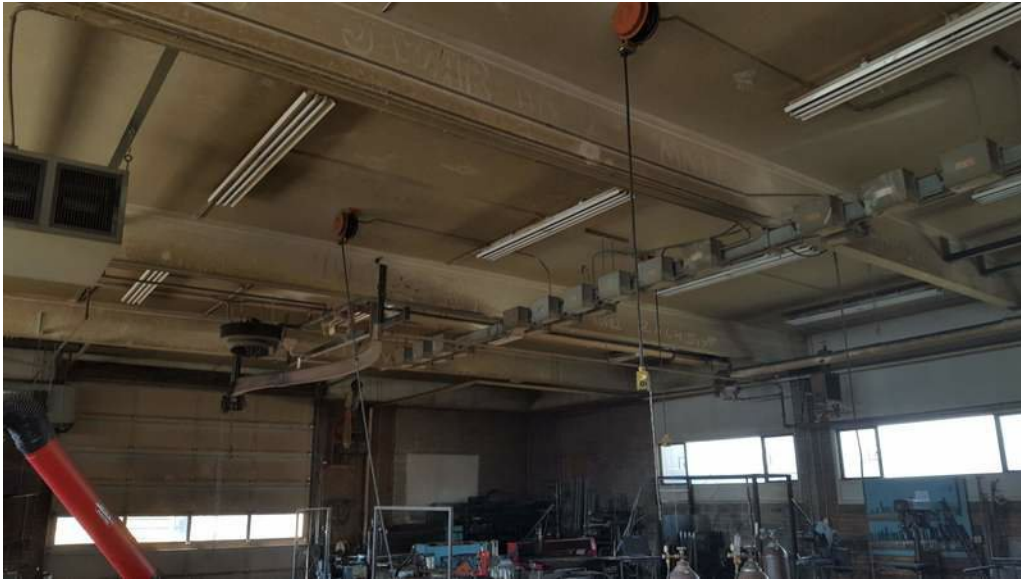
Figure 1-1. Glulam beams visible in the shop area.

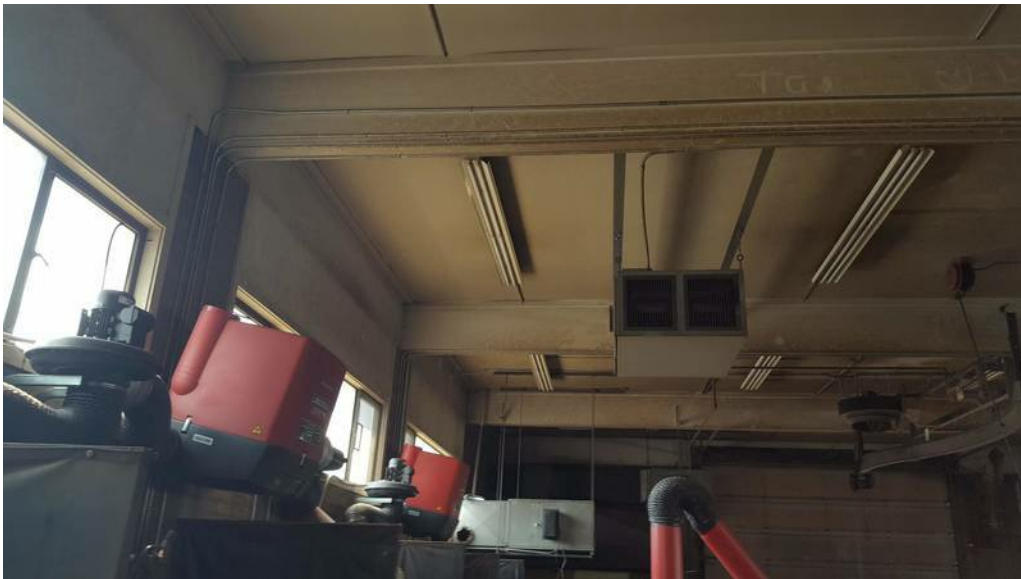
Figure 1-2. Glulam beams at CMU pilasters.

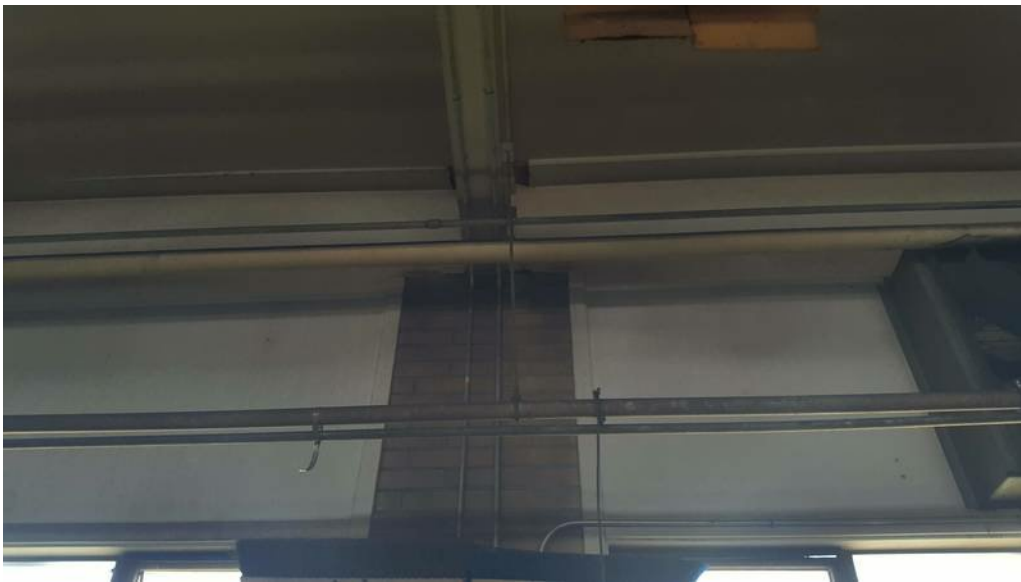
Figure 1-4. Glulam beam at CMU pilaster.

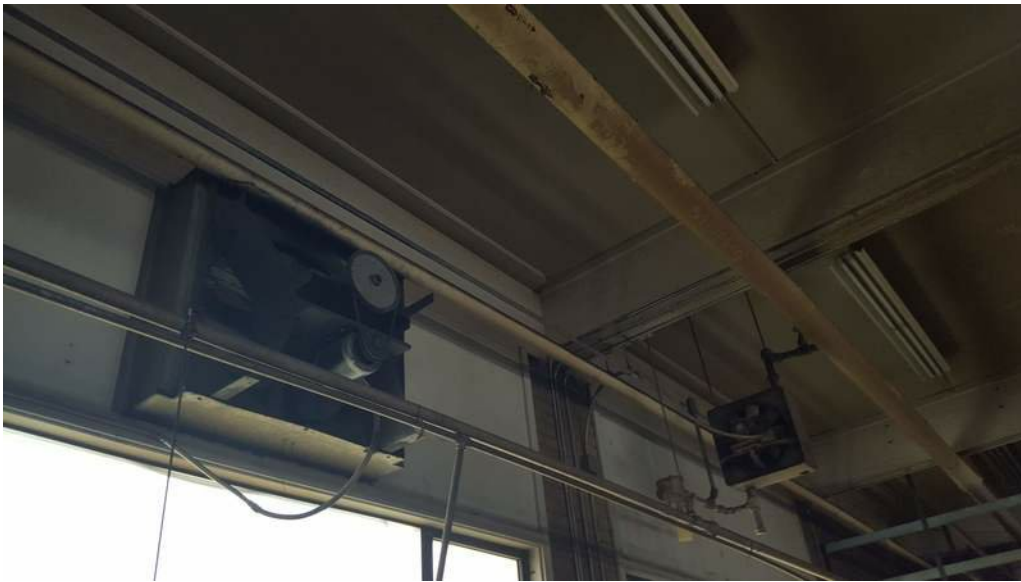
Figure 1-5. View of large vent located over a window and miscellaneous piping and mechanical units.

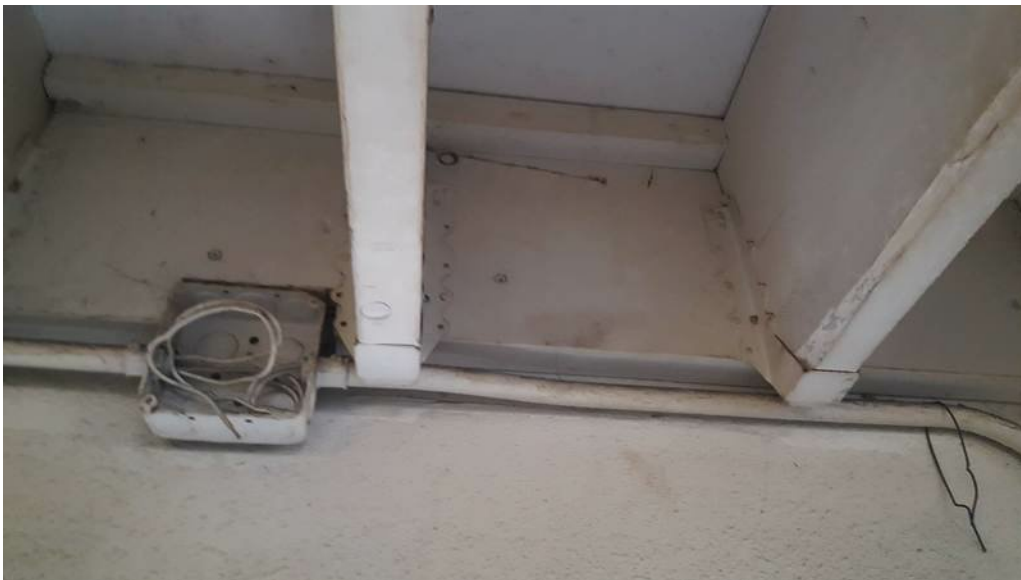
Figure 1-6. Mezzanine framing connection at ledger.

EVALUATION ITEM	EVALUATION STATEMENT	C	NC	N/A	U	COMMENT
Load Path	The structure contains a complete, well-defined load path, including structural elements and connections, that serves to transfer the inertial forces associated with the mass of all elements of the building to the foundation. (Tier 2: Sec. 5.4.1.1; Commentary: Sec. A.2.1.10)				X	The existing drawings received are incomplete architectural drawings only. Shear walls do not appear to be present on all sides, and the building has a plywood diaphragm.
Adjacent Buildings	The clear distance between the building being evaluated and any adjacent building is greater than 0.25% of the height of the shorter building in low seismicity, 0.5% in moderate seismicity, and 1.5% in high seismicity. (Tier 2: Sec. 5.4.1.2; Commentary: Sec. A.2.1.2)	X				
Mezzanines	Interior mezzanine levels are braced independently from the main structure or are anchored to the seismic-force-resisting elements of the main structure. (Tier 2: Sec. 5.4.1.3; Commentary: Sec. A.2.1.3)	X				The mezzanine was anchored to interior partition walls via a ledger.

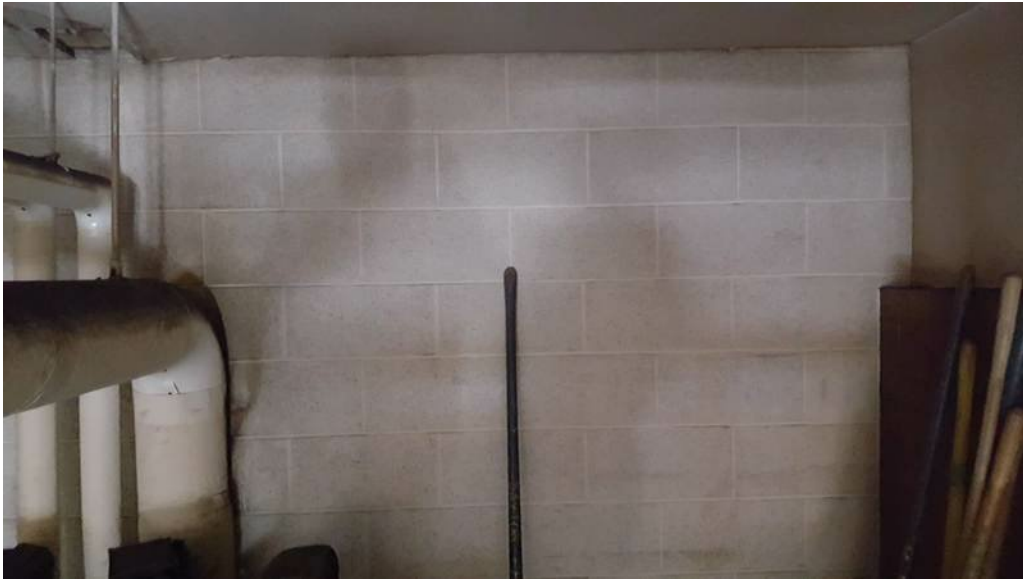
Figure 1-7. CMU infill wall.

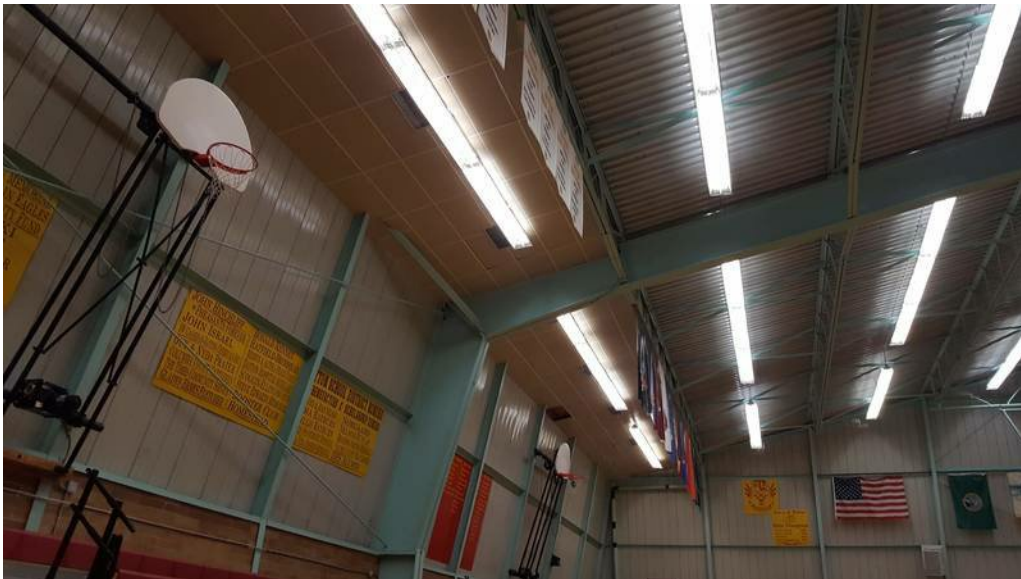
Figure 1-2. Gymnasium, looking northeast at one of two moment frames.

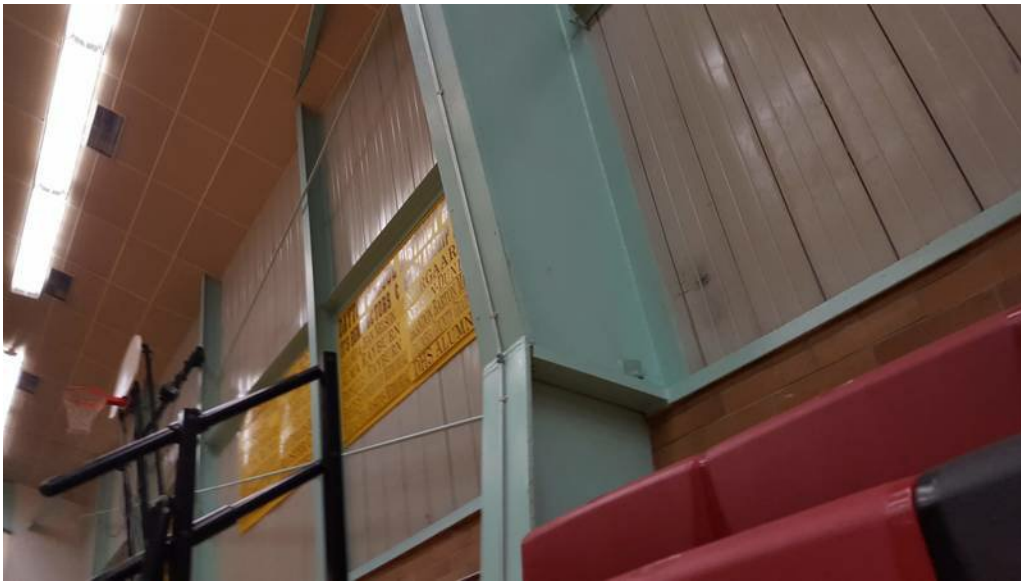
Figure 1-5. Moment frame panel point with rod bracing connection visible.

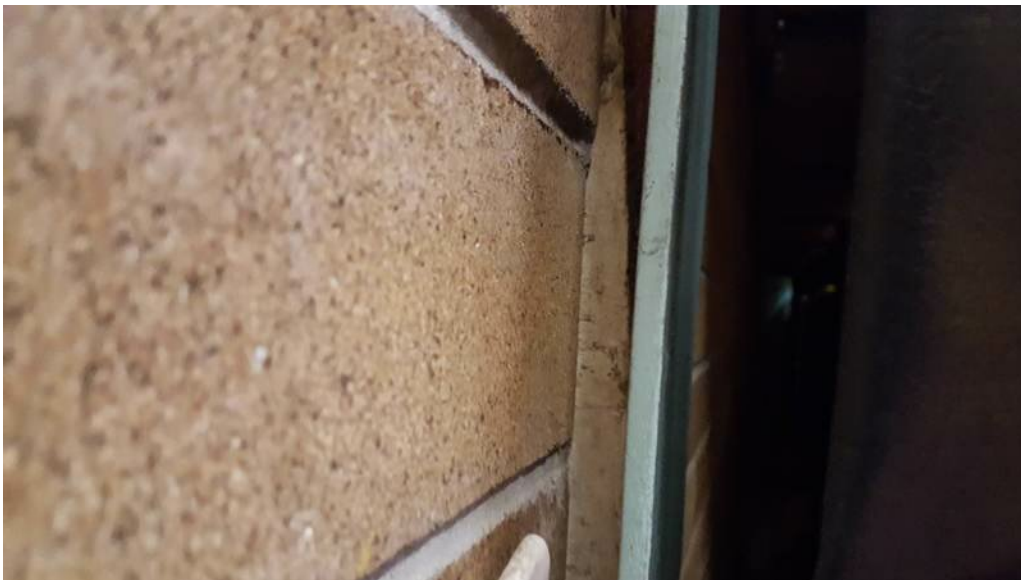
Figure 1-6. Gap between infill wall and intermediate column.

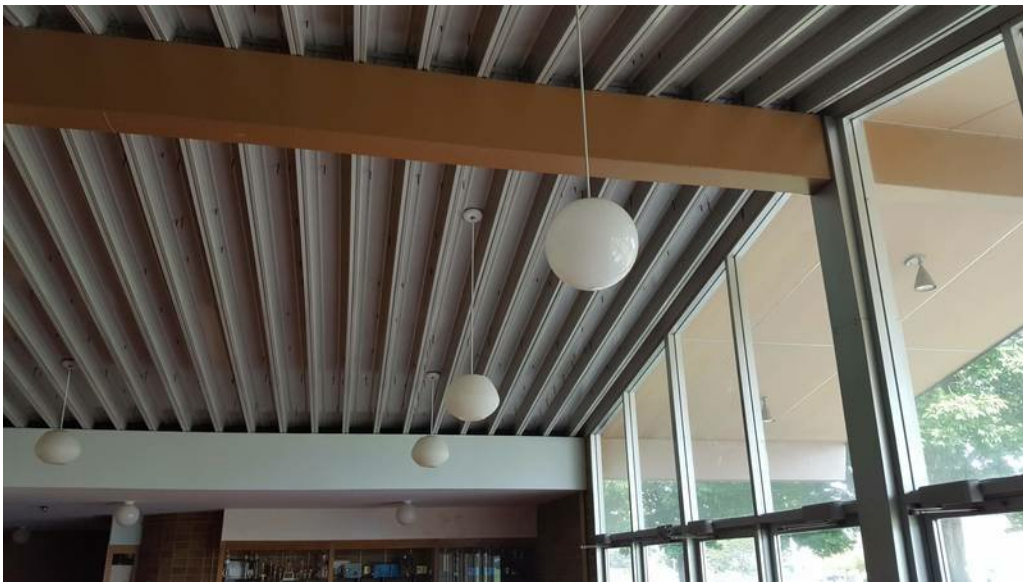
Figure 1-8. Front lobby ceiling.

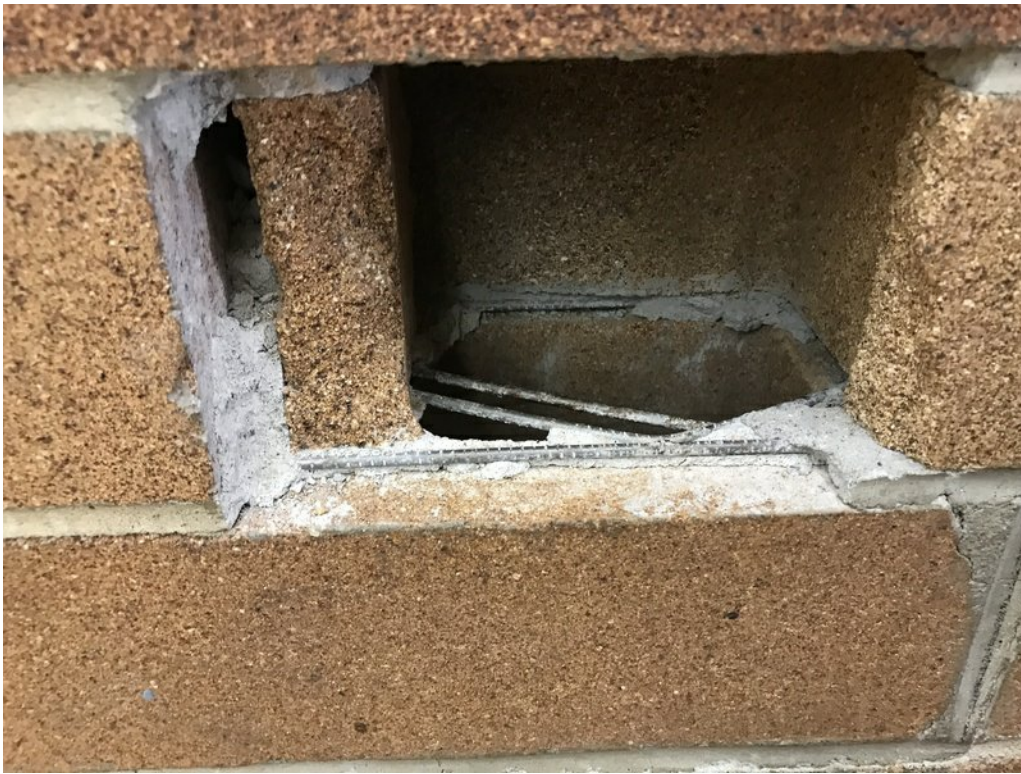
Figure 1-9. View of horizontal reinforcement.

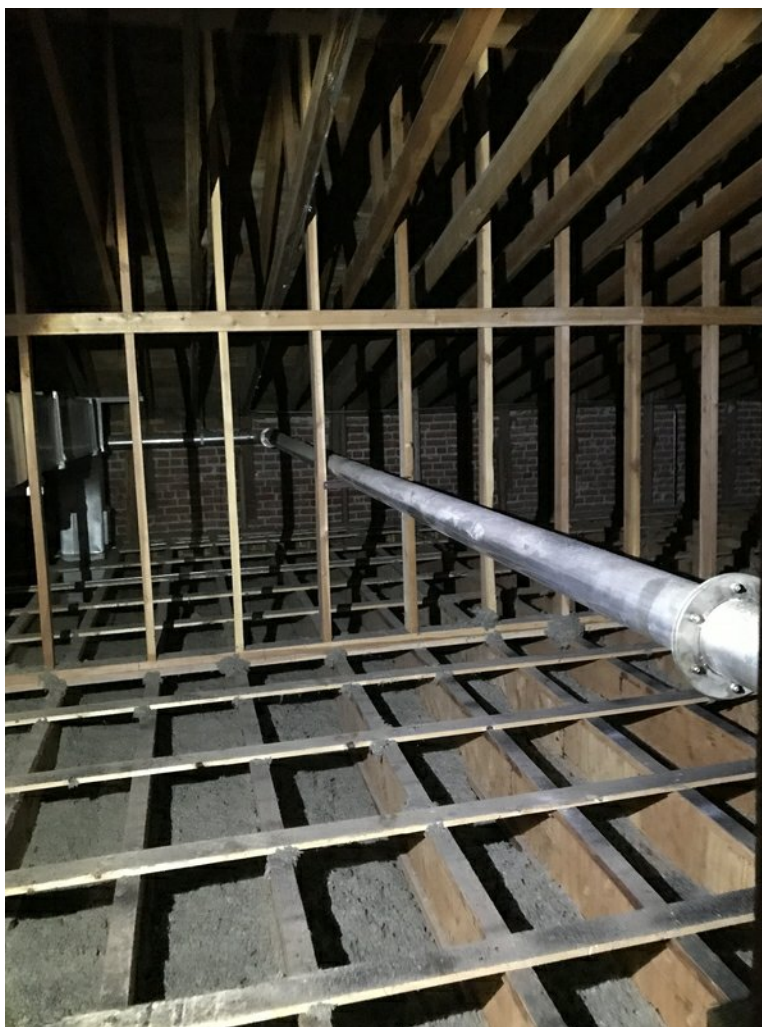
Figure 1-1. Attic space between wood I-joist ceilings and wood truss roof.

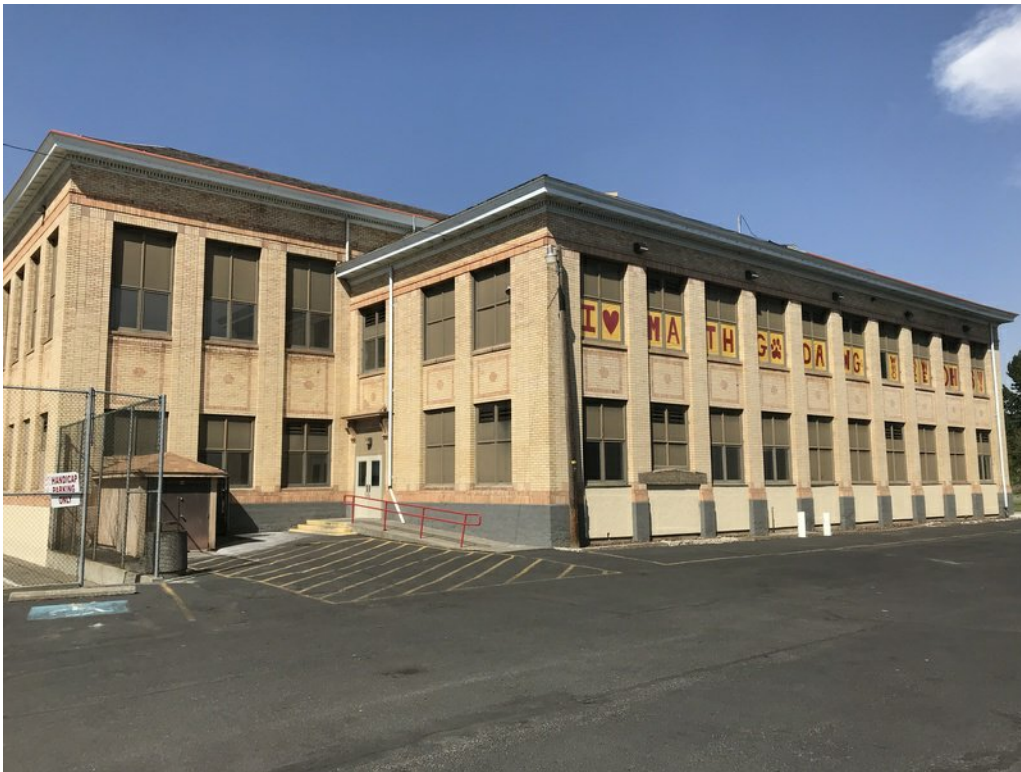
Figure 1-7. Southwest face of building

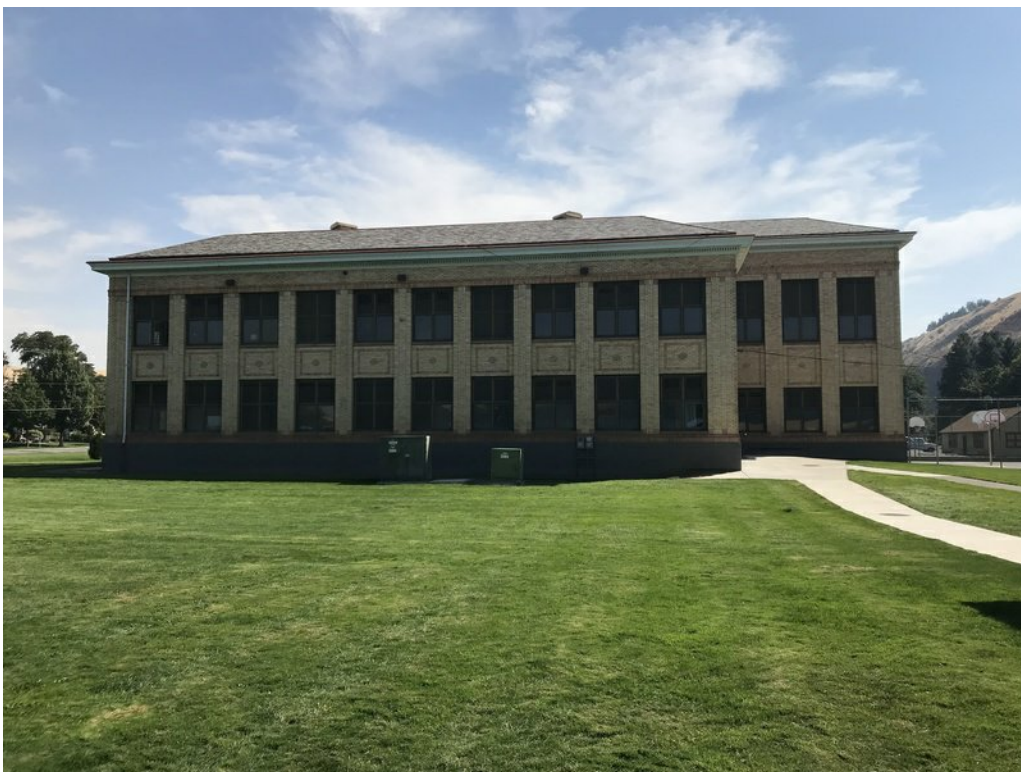
Figure 1-8. Northwest face of building.

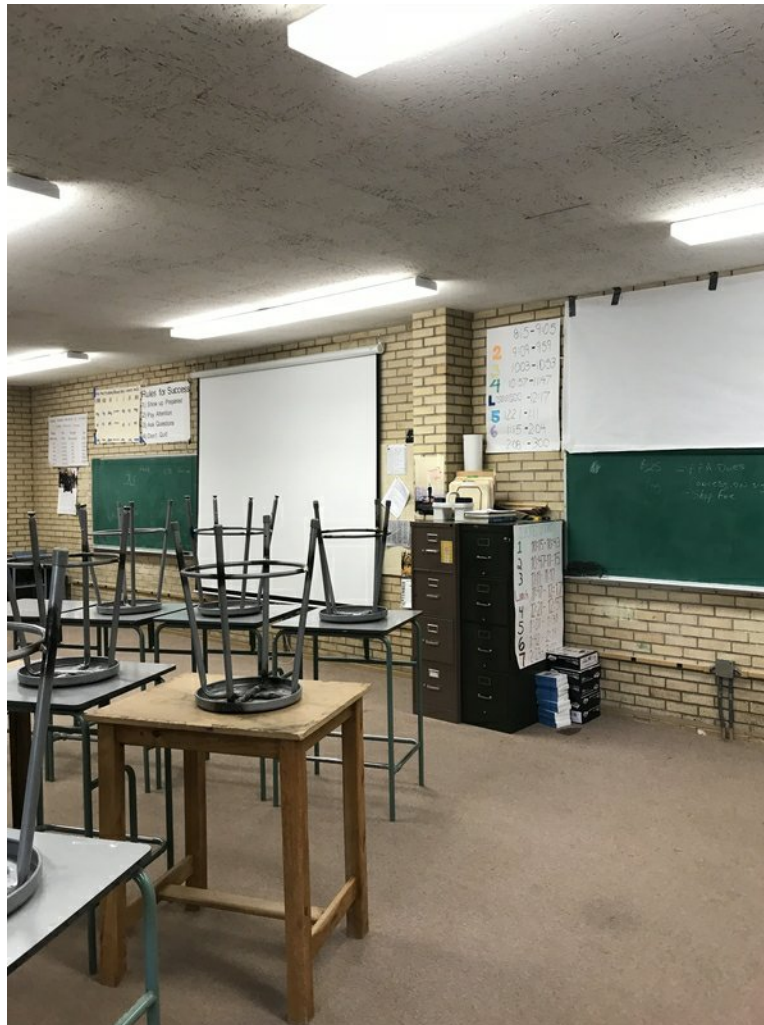
Figure 1-1. Classroom space at "middle" of building.

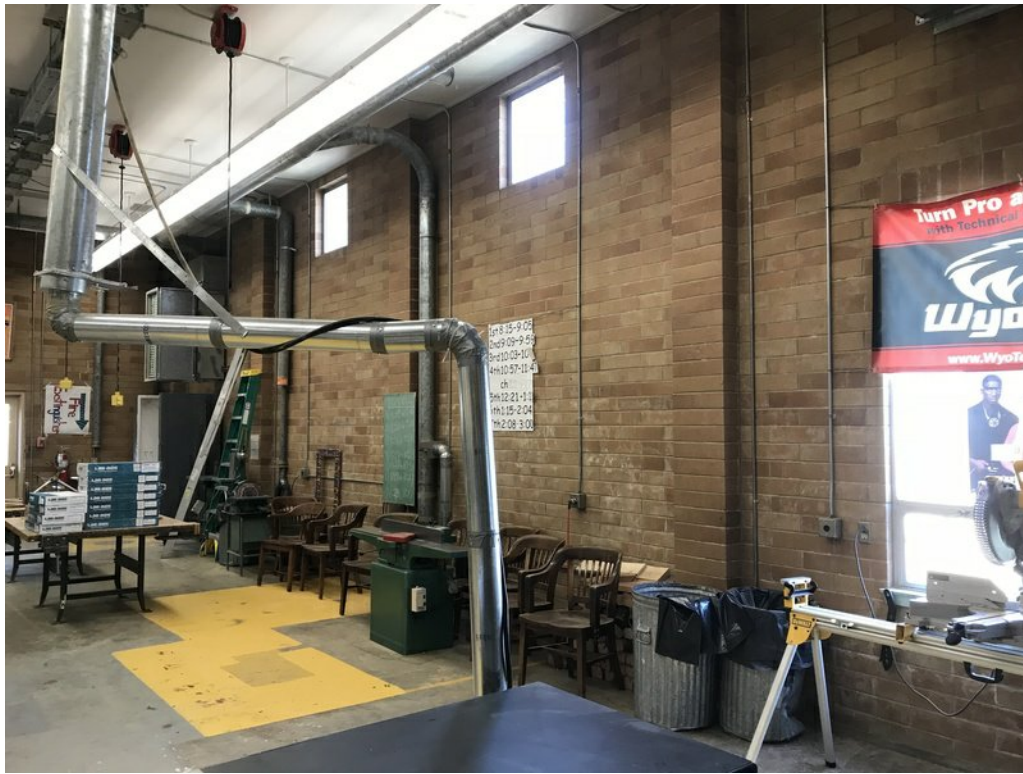
Figure 1-2. View in wood shop area.

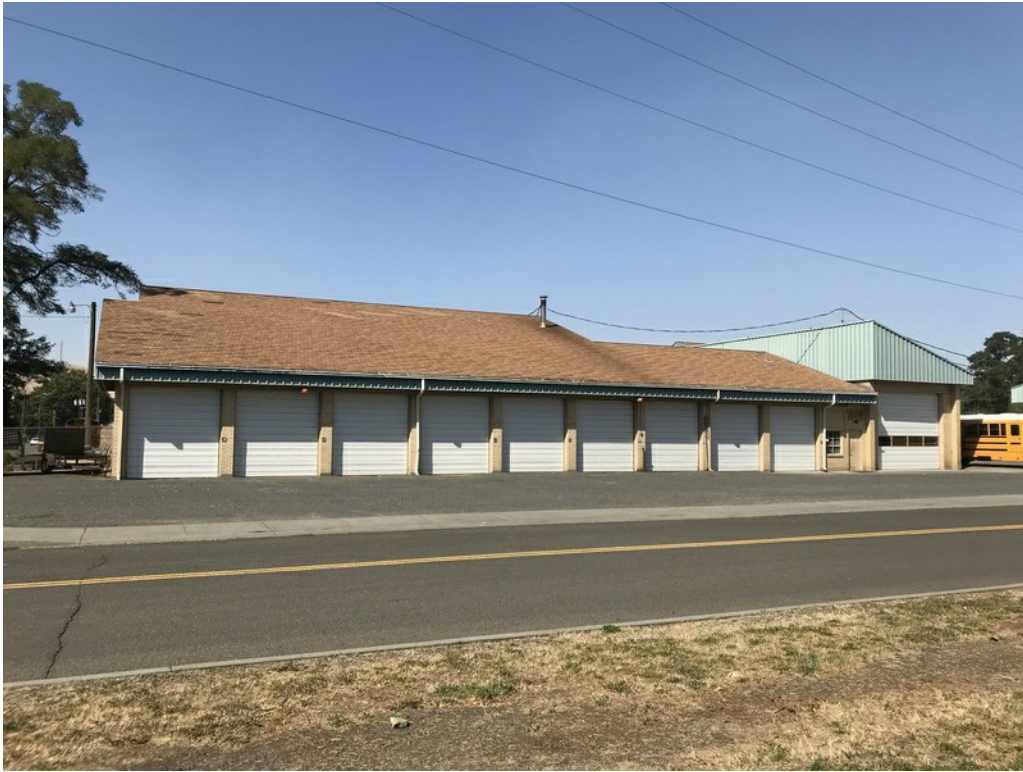
Figure 1-6. Southeast face of building.

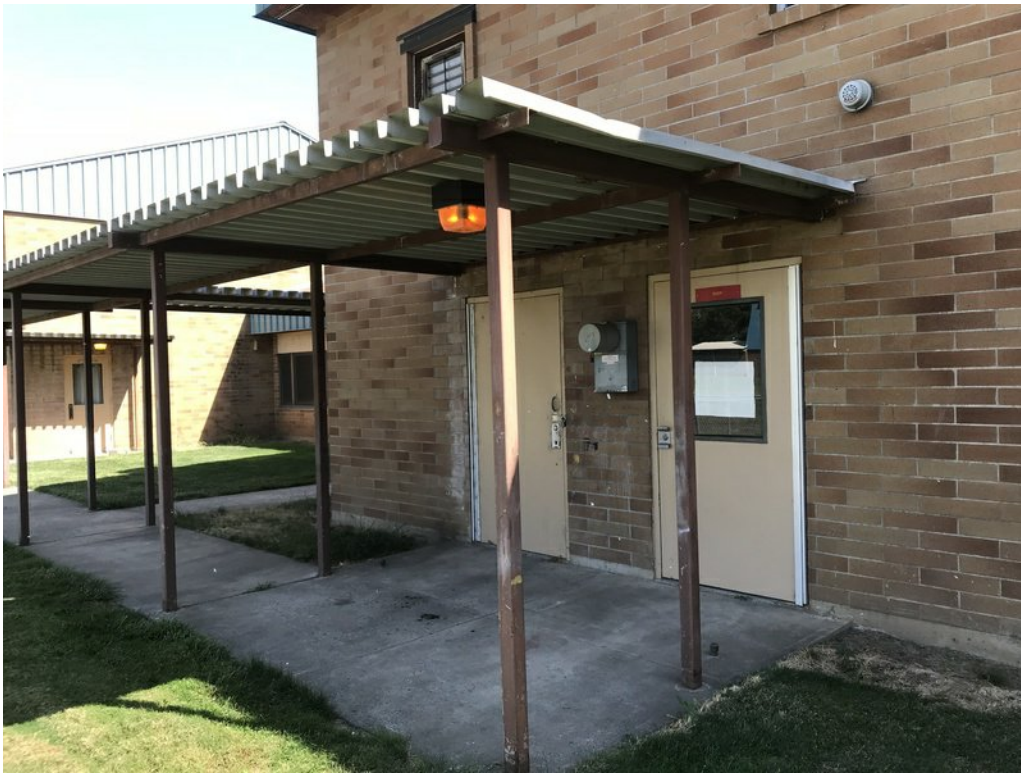
Figure 1-8. Canopy over wood shop entrance.

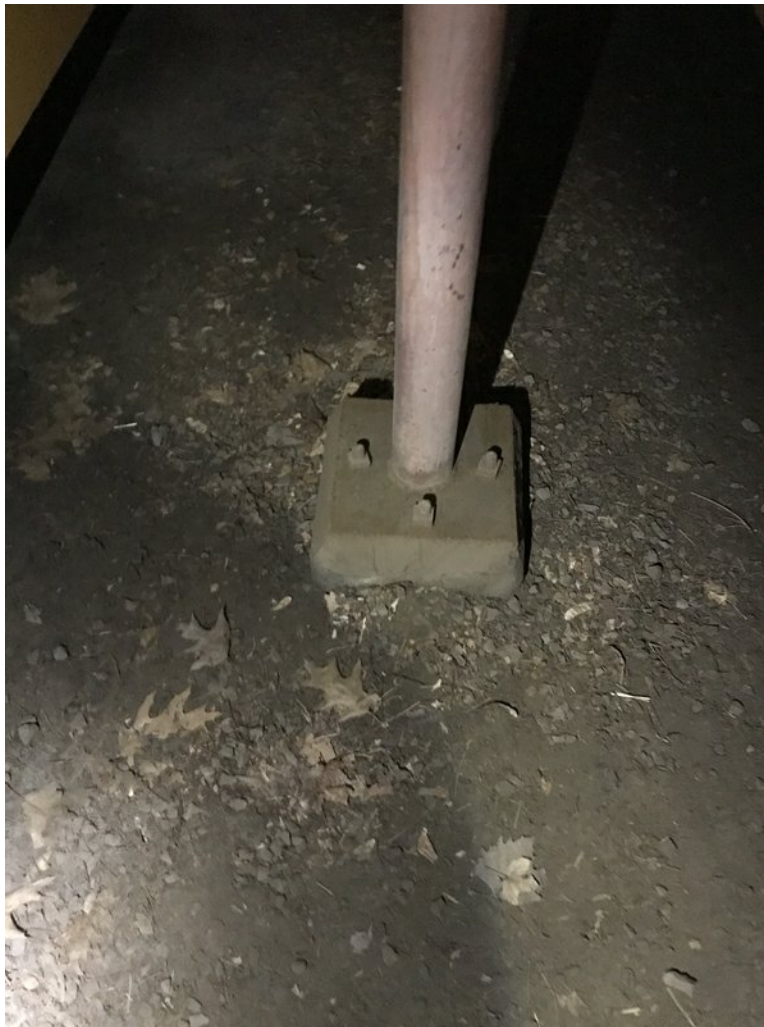
Figure 1-10. Footing for column in bus barn.

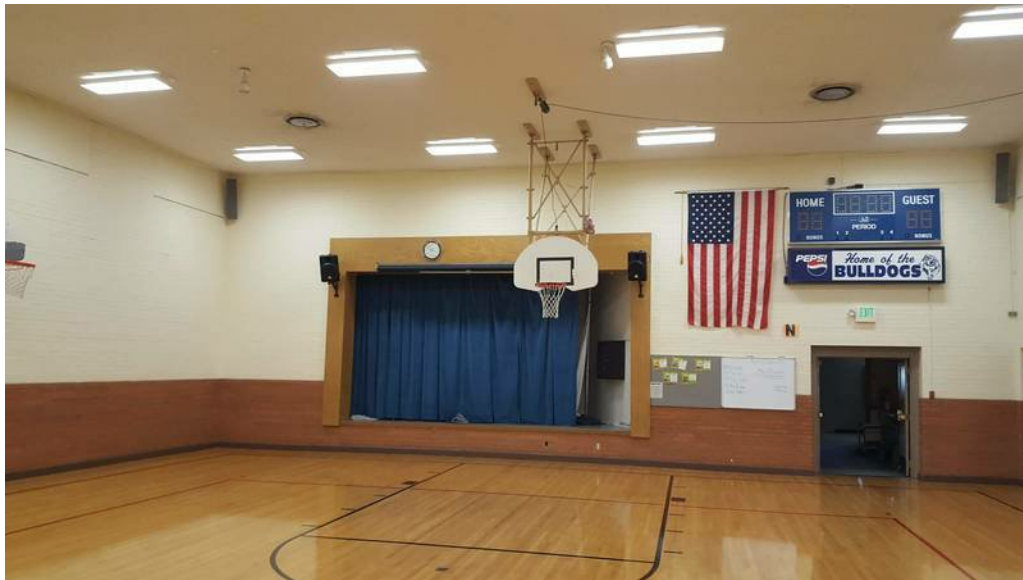
Figure 1-1. Gymnasium with stage.

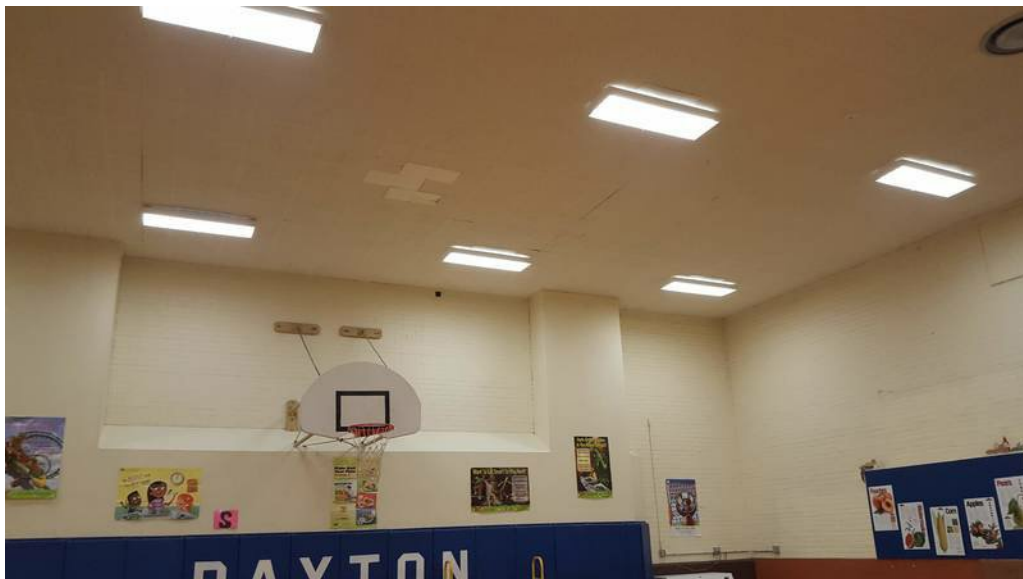
Figure 1-2. Gymnasium.

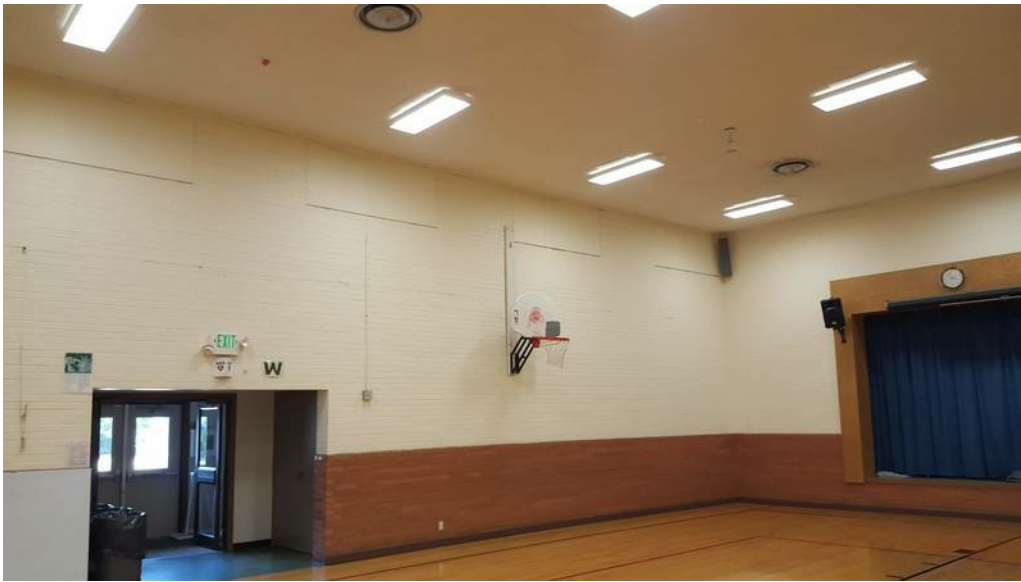
Figure 1-3. Gymnasium exterior wall.

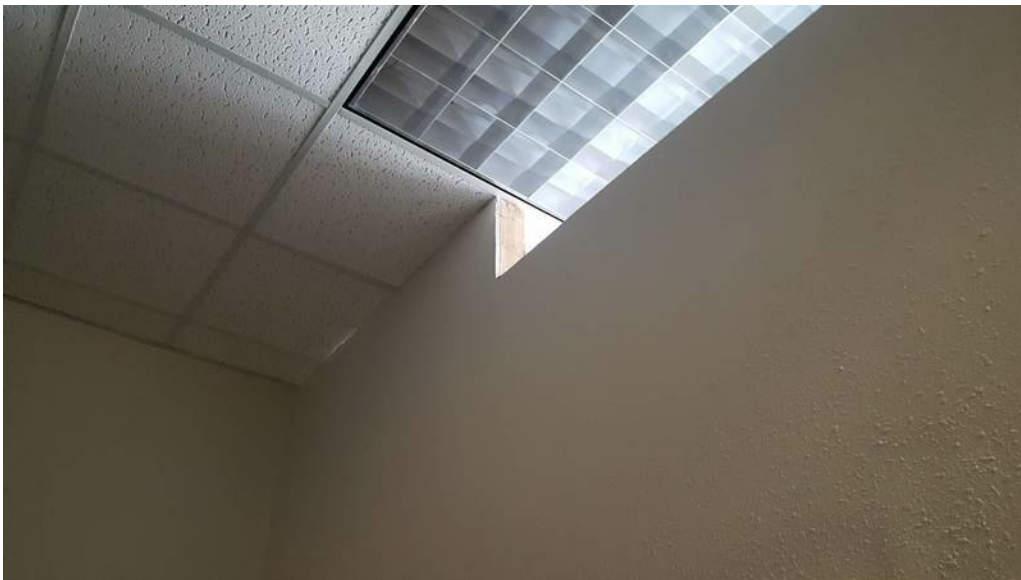
Figure 1-4. Wood-framed partition wall built under drop-in acoustical ceiling.

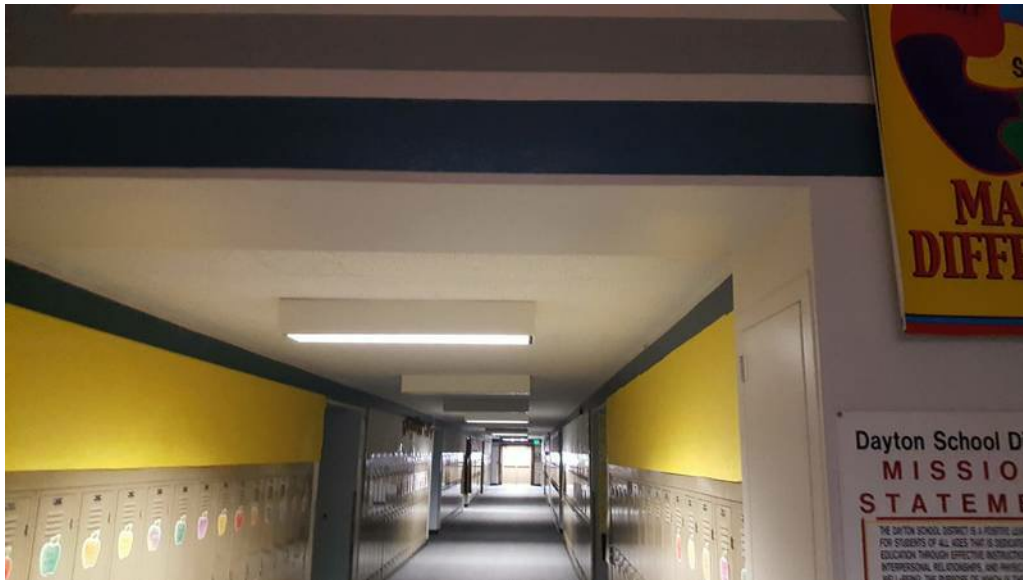
Figure 1-5. Corridor with lockers.

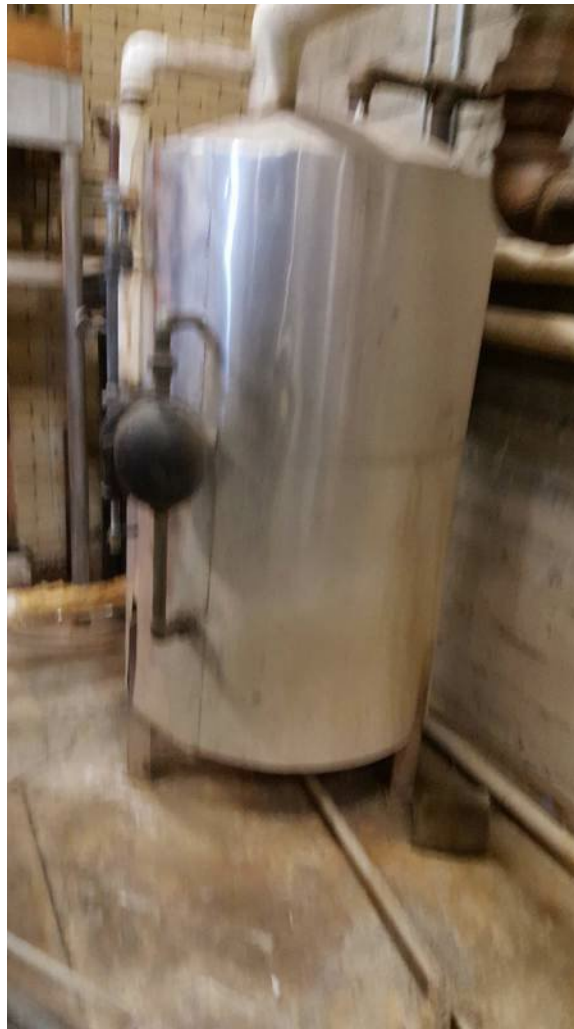
Figure 1-8. Boiler with no visible seismic strapping.

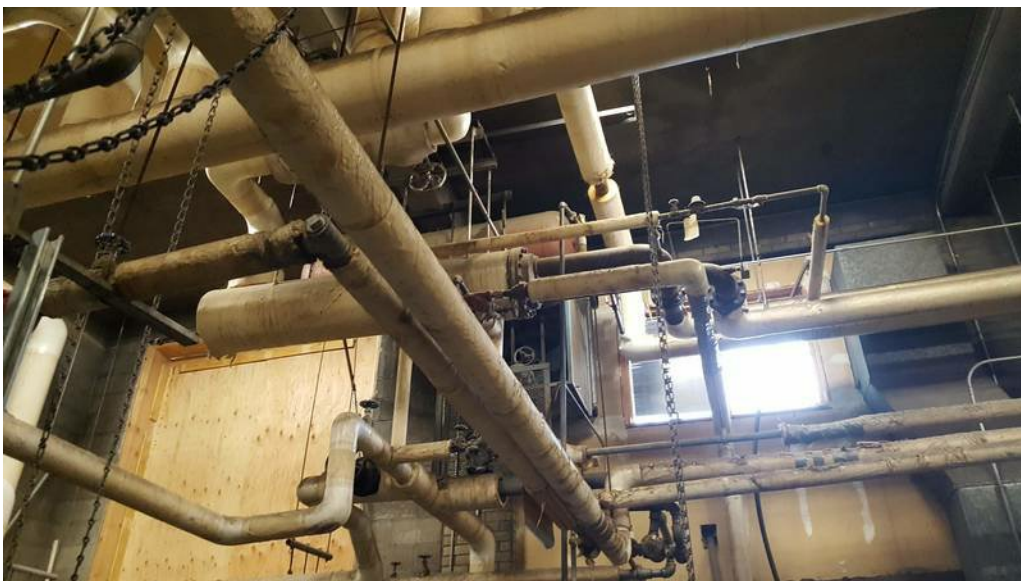
Figure 1-9. Miscellaneous piping in mechanical space.
